Figure 1. Location of Ralston Ranch fence repair project.

FOUR WIRE FENCE

JACKLEG FOUR WIRE FENCE DETAIL

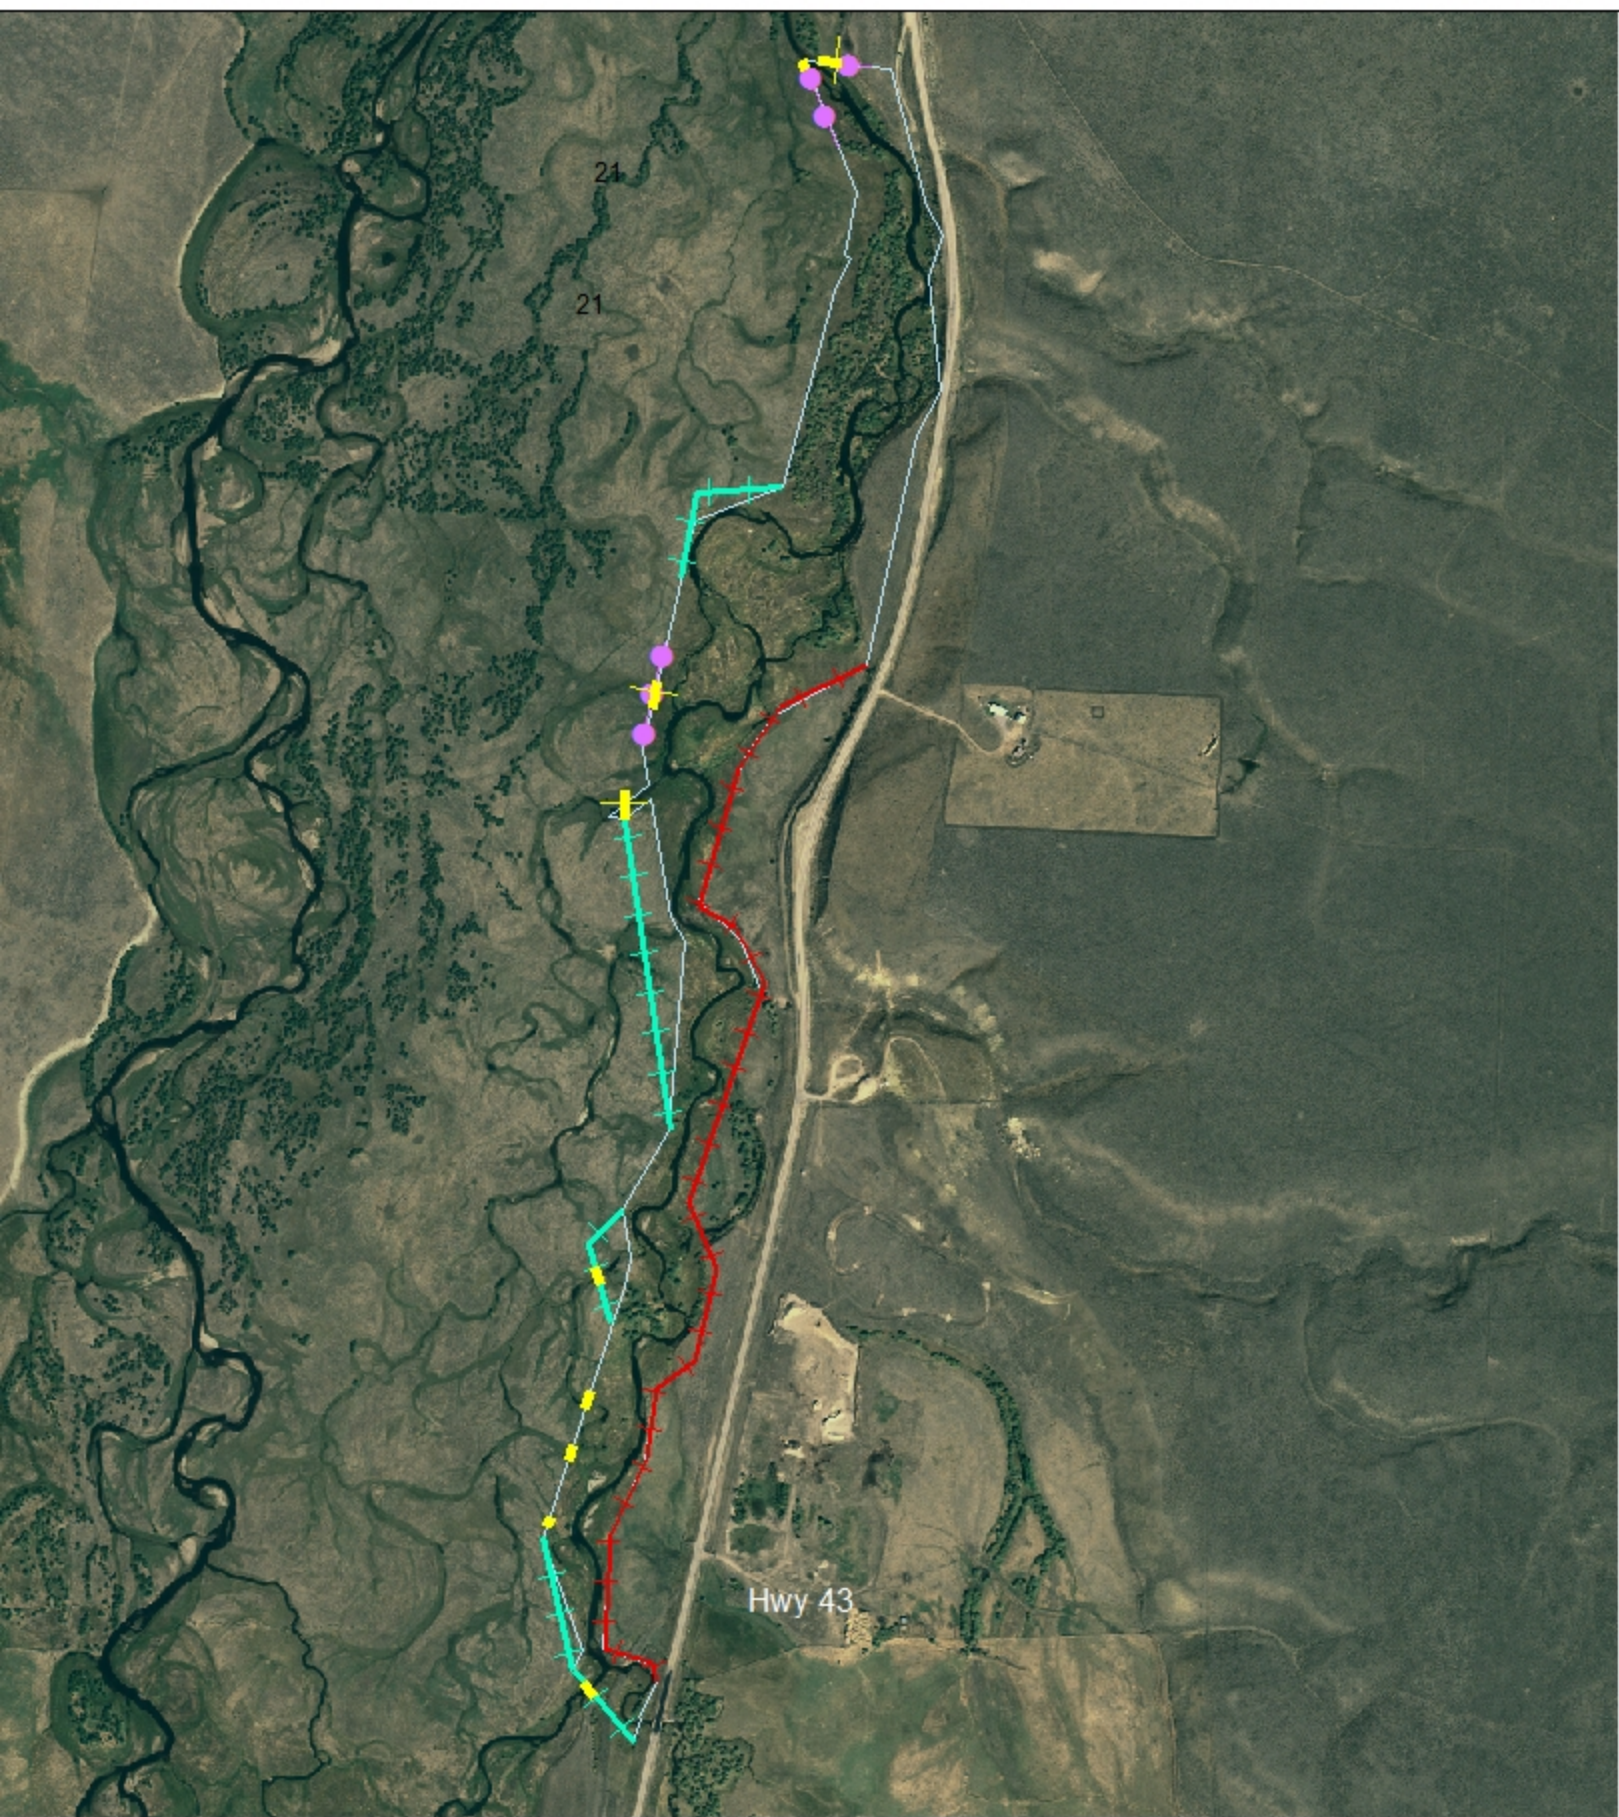
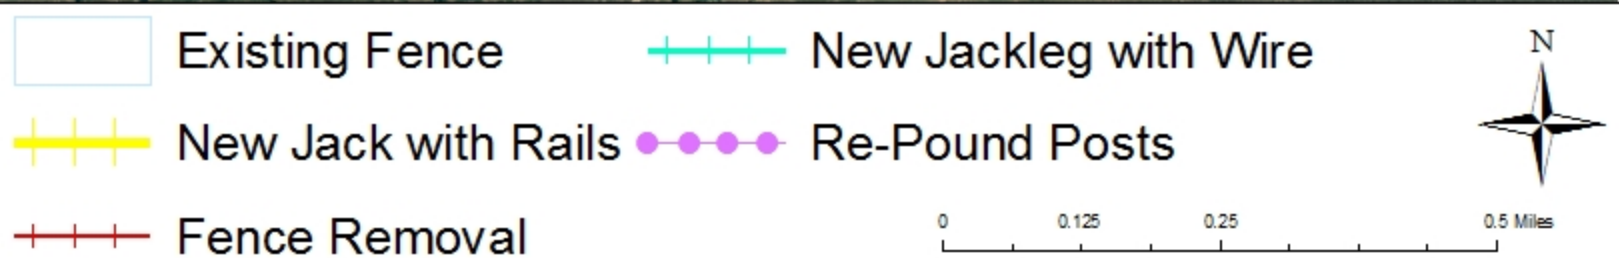
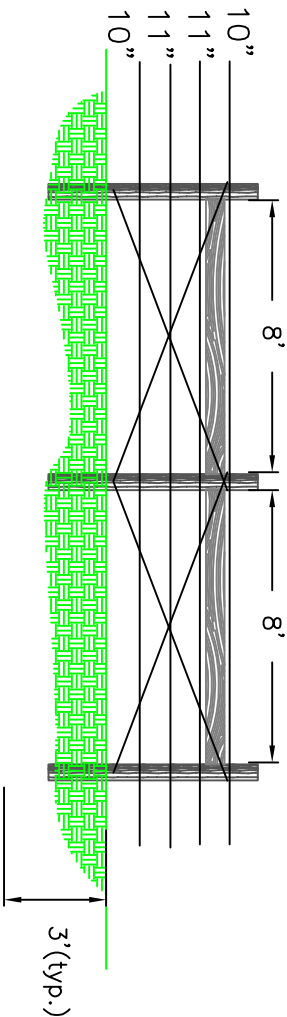
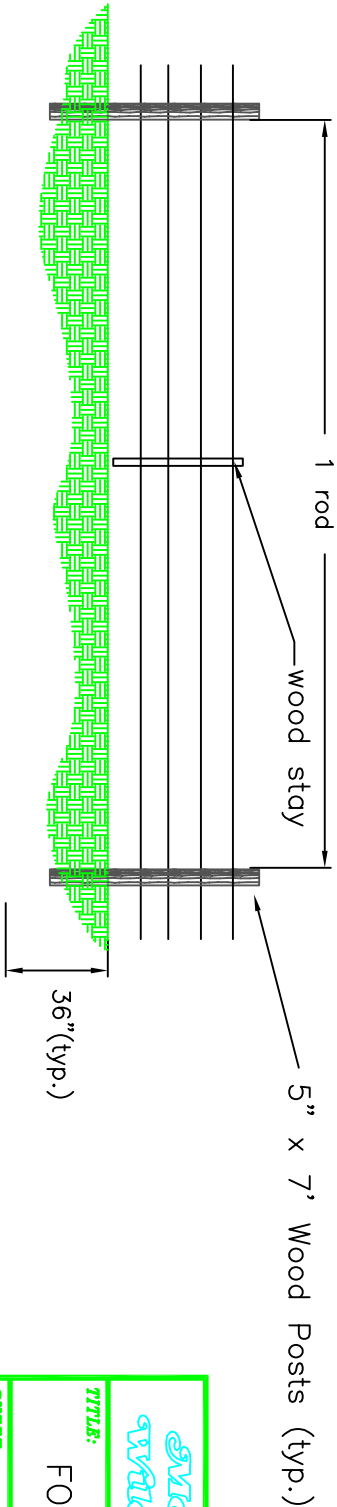
Four Wire Fence

Double Panel

W/Wood Post

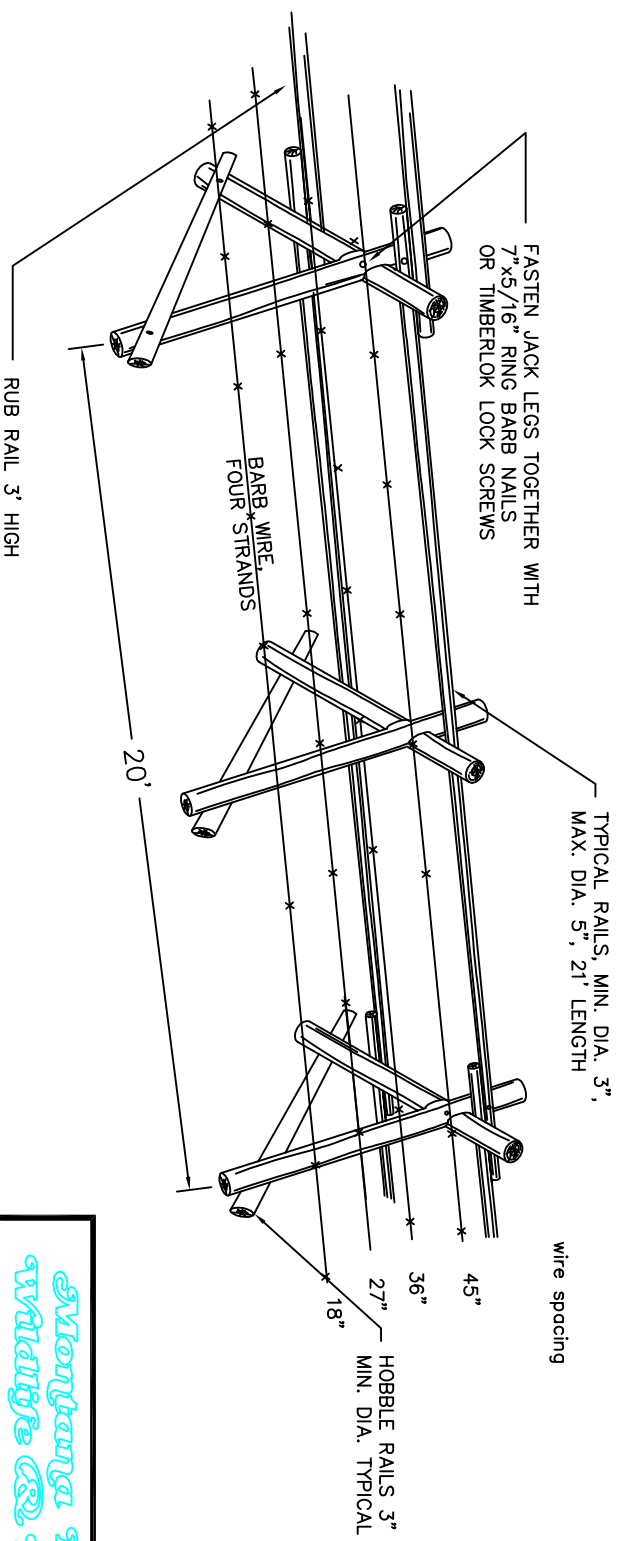
JACKLEG 4 WIRE FENCE BRACE WITH RUB RAIL DETAIL

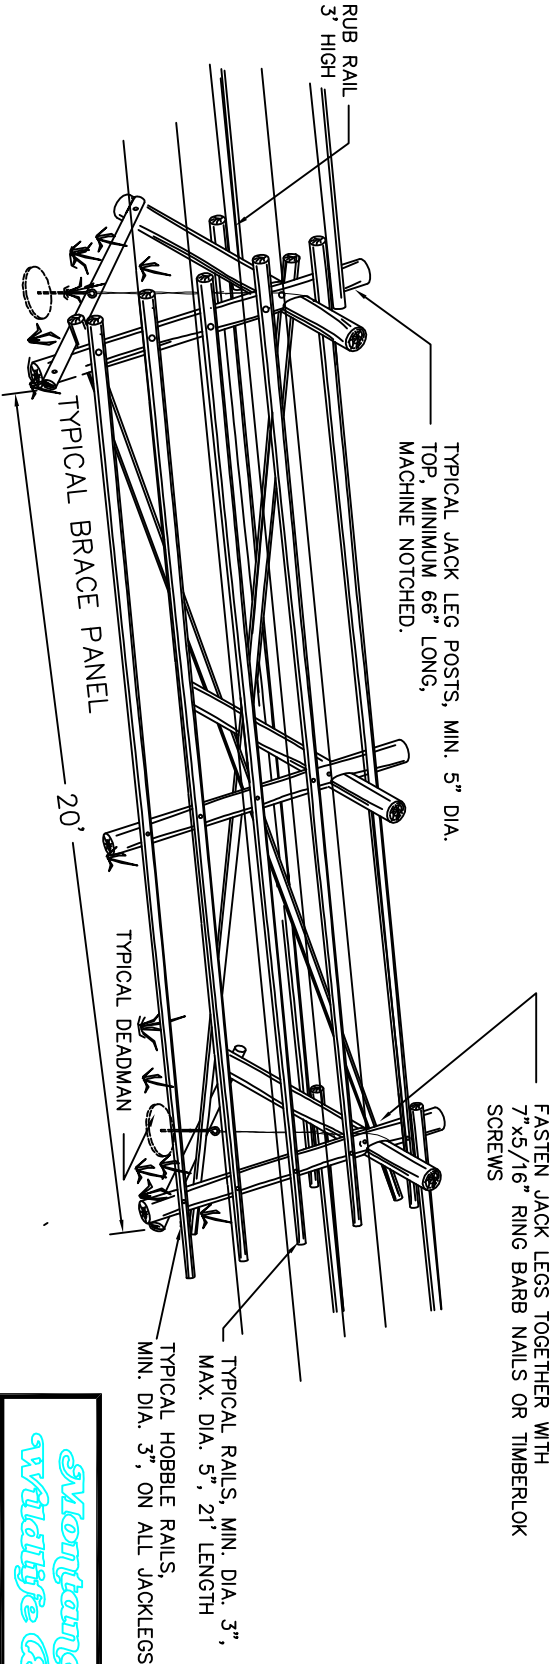
JACK LEG BRACE WITH RUB RAIL

JACKLEG RAIL WITH RUB RAIL DETAIL (NO SCALE)
